Contract #: 04-0120F4Cty: SF/ALA Rte: 80 PM: 13.2/13.9File #: 69.28**WELDING INSPECTION REPORT****Resident Engineer:**Siegenthaler, Peter**Address:** 333 Burma Road**City:** Oakland, CA 94607**Report No:** WIR-018037**Date Inspected:** 25-Oct-2010**Project Name:** SAS Superstructure**OSM Arrival Time:** 700**Prime Contractor:** American Bridge/Fluor Enterprises, a JV**OSM Departure Time:** 1900**Contractor:** Zhenhua Port Machinery Company, Ltd (ZPMC), Changxing Island **Location:** Shanghai,China

Bridge No: 34-0006**Summary of Items Observed:**

WELDING INSPECTION REPORT

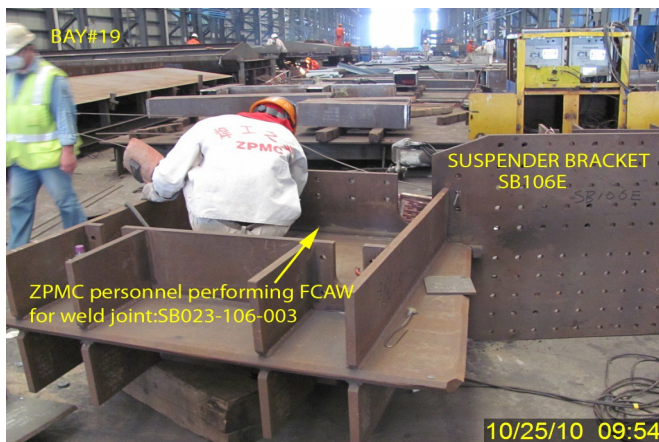
This QA Inspector observed the following work in progress:

FCAW in the 1G position for the OBG Segment Suspender Bracket SB106E, The weld joint was designated as: SB023-106-003. The welder is identified as #058792. ABF QA is identified as Mr. Peng Wei Jun. The welding variables recorded by QC appear to comply with WPS-B-T-2231-TC-U4b-F. Please see the attached picture.

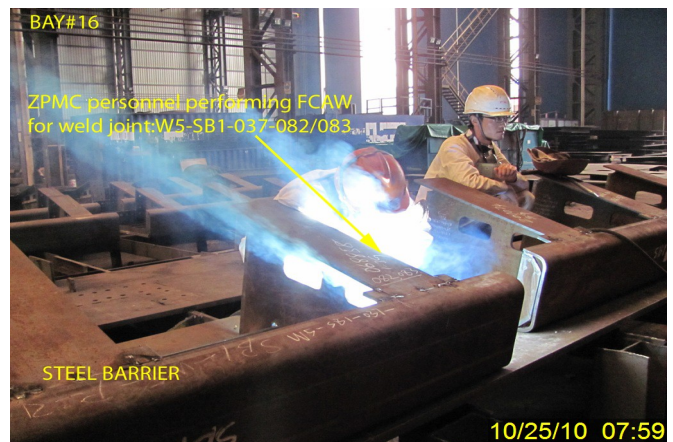
This QA Inspector observed the following work in progress:

FCAW in the 2F position for the OBG Segment Steel Barrier, The weld joint was designated as: W5-SB1-037-082/083. The welder is identified as #068858. ZPMC QC is identified as Mr. Gu Pan. The welding variables recorded by QC appear to comply with WPS-B-T-2132. Please see the attached picture.
